eDNA surveying in the North Pennines National Landscape

Stephen Henderson and
Rachel Hutchinson

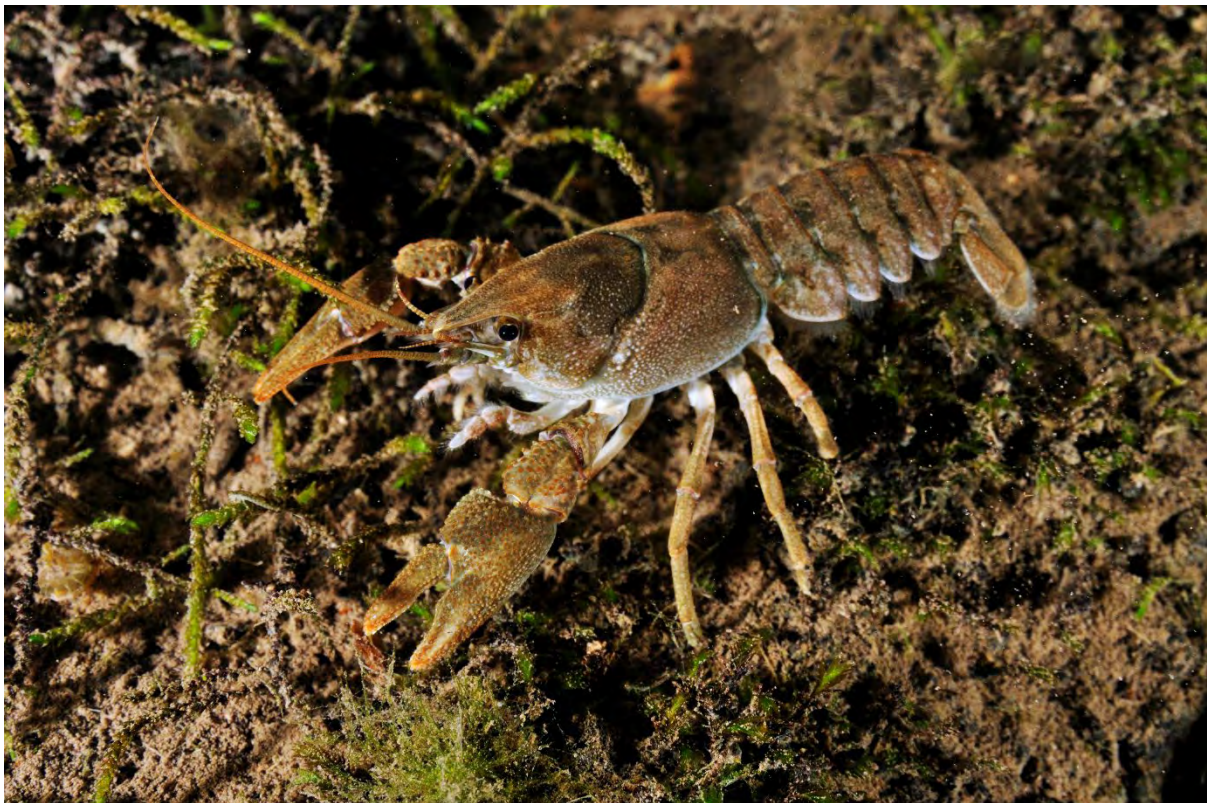
Figure 2: Photo of white-clawed crayfish. Photo credit: Linda Pitkin 2020 Vision

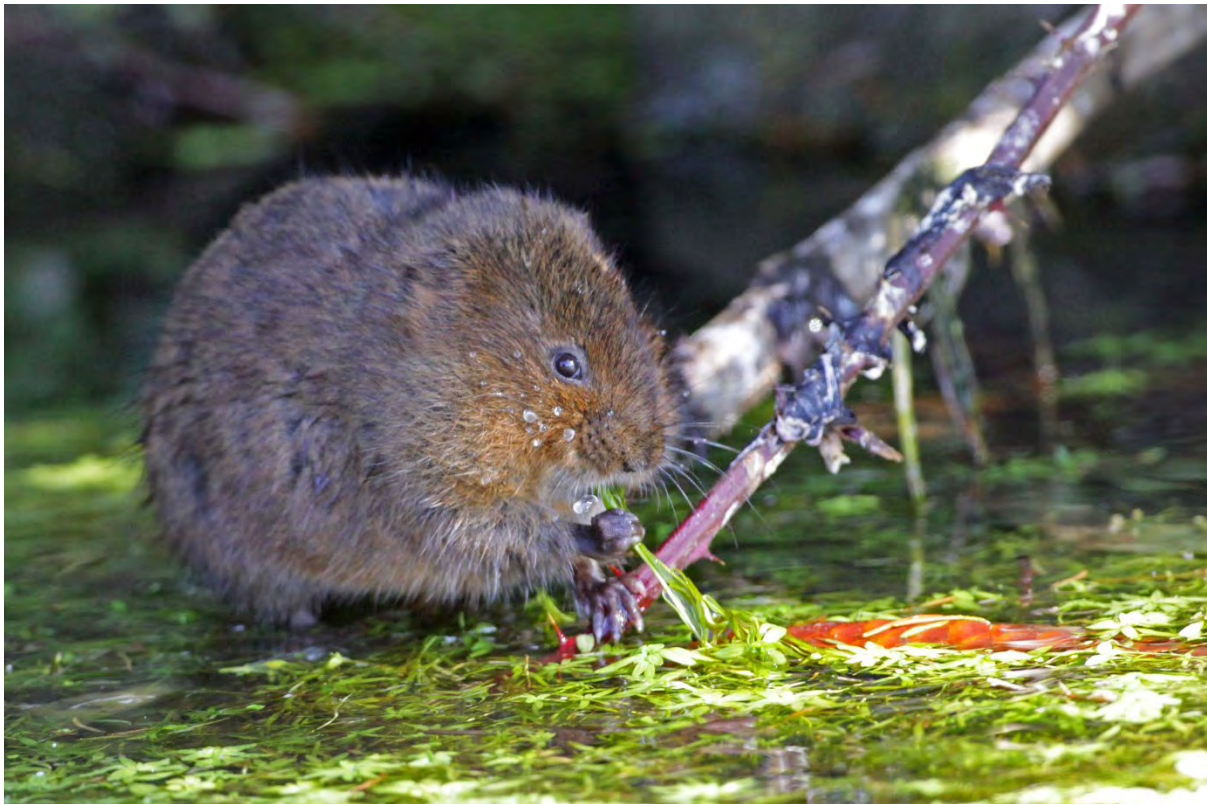
Figure 3: Photo of water vole. Photo credit: Margaret Holland.

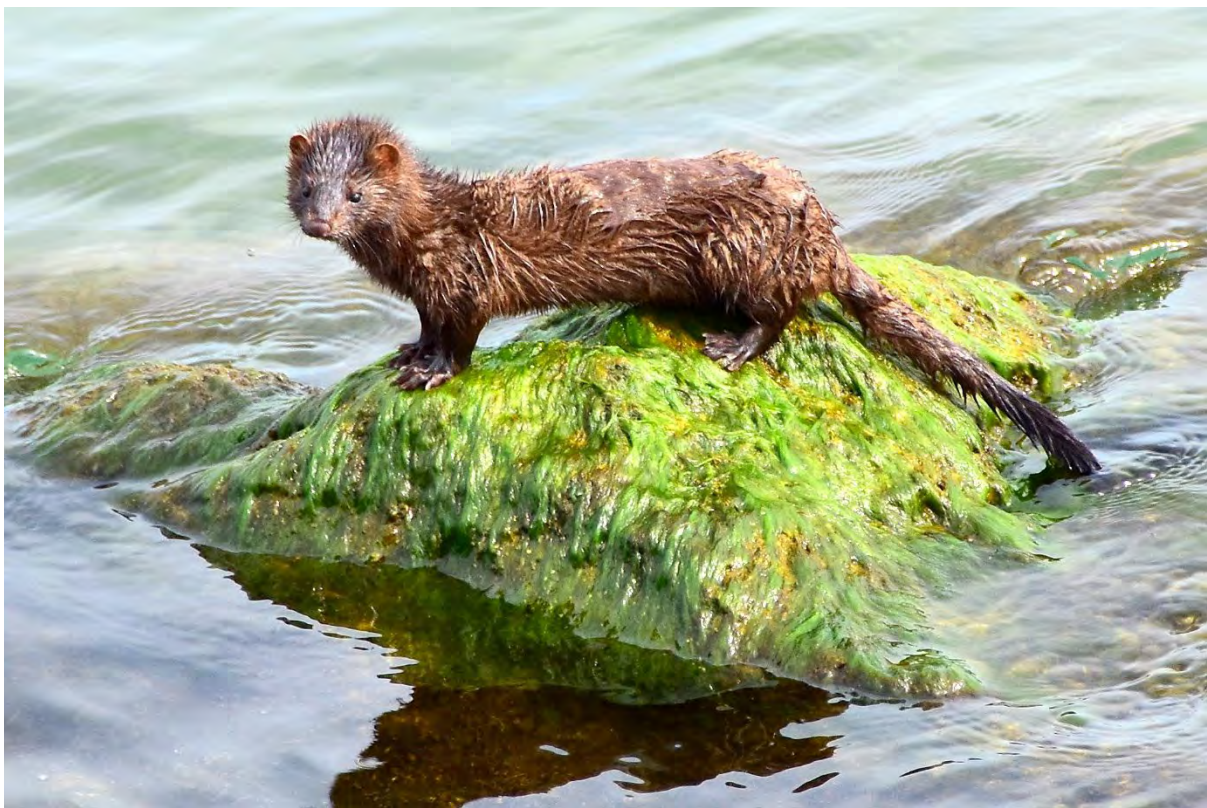
Figure 4: Photo of American Mink. Photo credit: Jan den Ouden

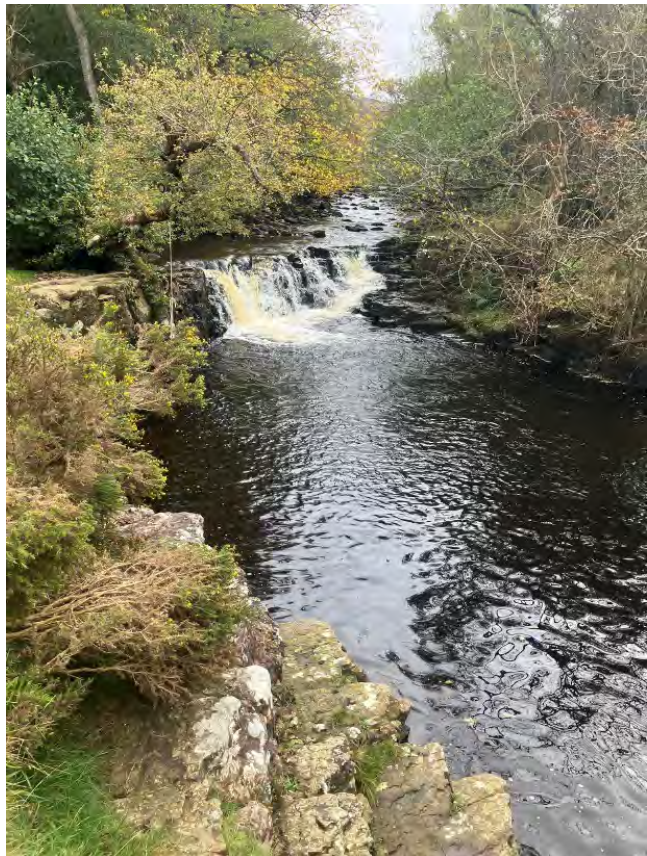
Figure 9: Photo of waterfall on the River Gelt

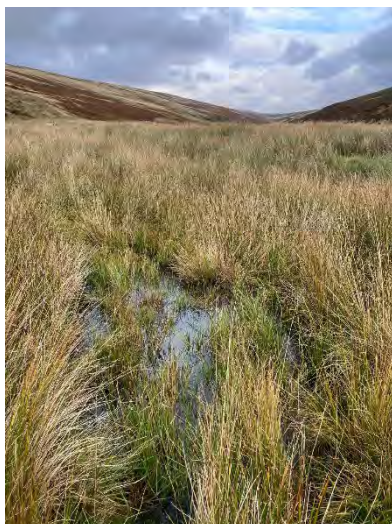
Figure 19: Photo of slow flowing back channel in New Water
